4S4BSAAC5H3399222

## Vehicle details

## Hereinnahmebewertung

Inspection date: 22 Jul 2026  
**Protocol number:** 46635424  
Created by: Marcel Cohen  
Inspected by: M. Cohen

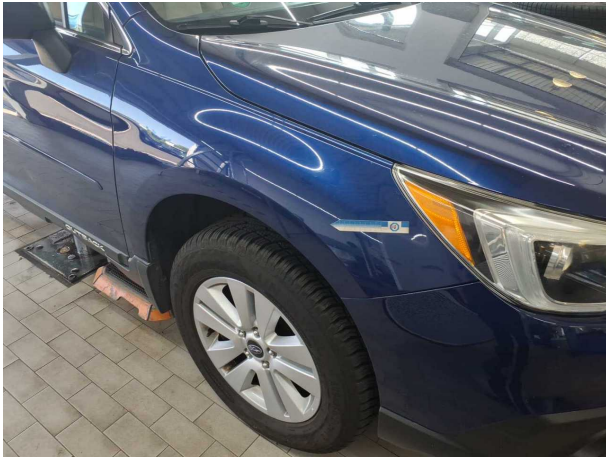
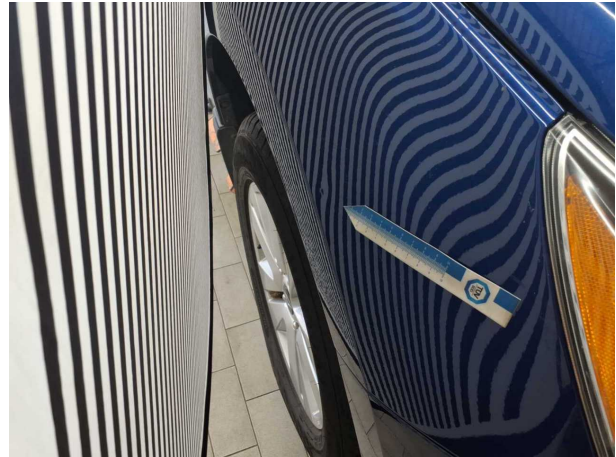
| No. | Component group | Description | Costs (Net) |
|---|---|---|---|
| 1 | Mudguard - right side | Mudguard - right side - dent(s) - Smooth repair work | 90,00 € |

**Damage #1:** Mudguard - right side: Mudguard - right side - dent(s) - Smooth repair work

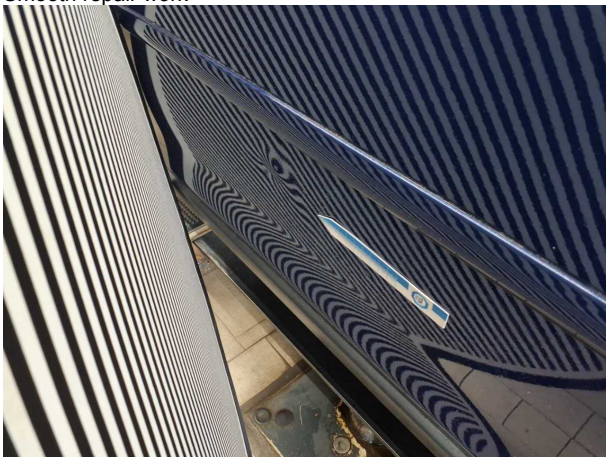
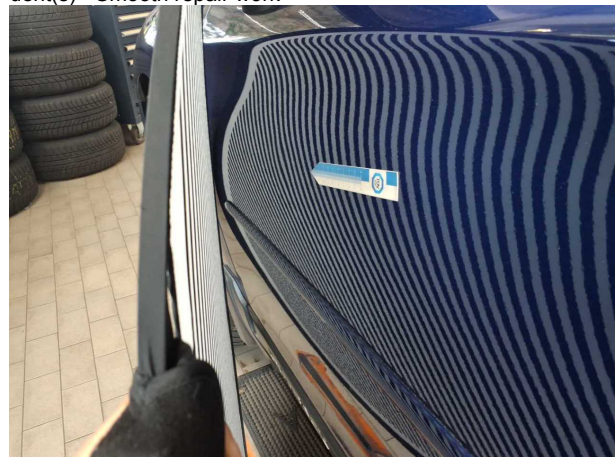
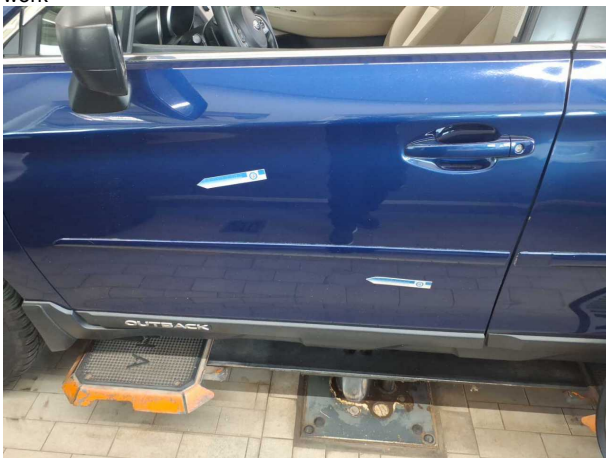
| No. | Component group | Description | Costs (Net) |
|---|---|---|---|
| 2 | Door - front left side | Door - dent(s) - Smooth repair work | 130,00 € |

**Damage #2:** Door - front left side: Door - dent(s) - Smooth repair work

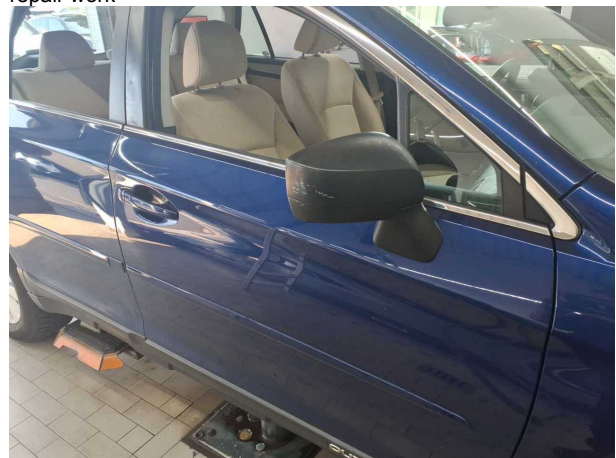
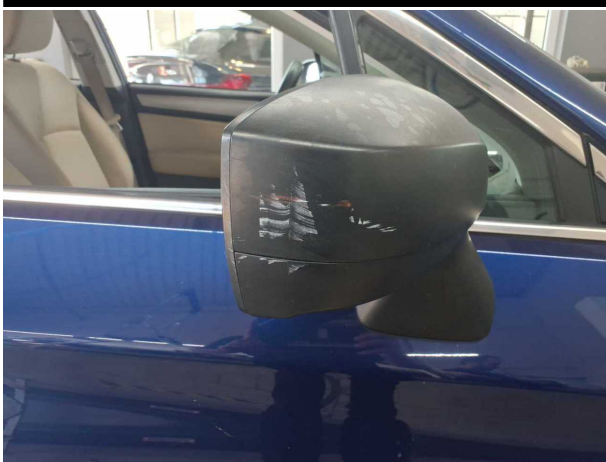
| No. | Component group | Description | Costs (Net) |
|---|---|---|---|
| 3 | Wing mirror - right side | Wing mirror - Scratched - Replace | 150,00 € |

**Damage #3:** Wing mirror - right side: Wing mirror - Scratched - Replace

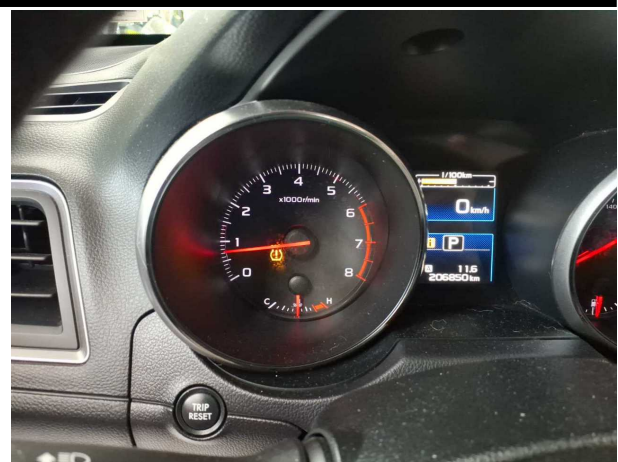
| No. | Component group | Description | Costs (Net) |
|---|---|---|---|
| 4 | Instrument panel | Indicator light (Reifen, vorbehaltlich Folgekosten) - on - Diagnosed and repair if necessary | 250,00 € |

**Damage #4:** Instrument panel: Indicator light (Reifen, vorbehaltlich Folgekosten) - on - Diagnosed and repair if

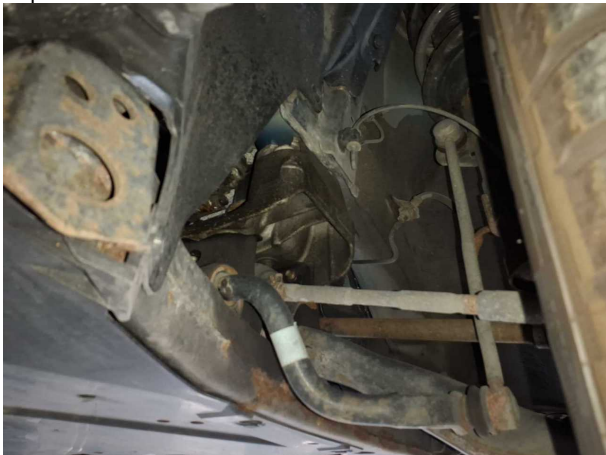
| No. | Component group | Description | Costs (Net) |
|---|---|---|---|
| 5 | Engine | Engine (Vorbehaltlich Folgekosten) - Leaking - Diagnosed and repair if necessary | 250,00 € |

**Damage #5:** Engine: Engine (Vorbehaltlich Folgekosten) - Leaking... Diagnosed and repair if necessary

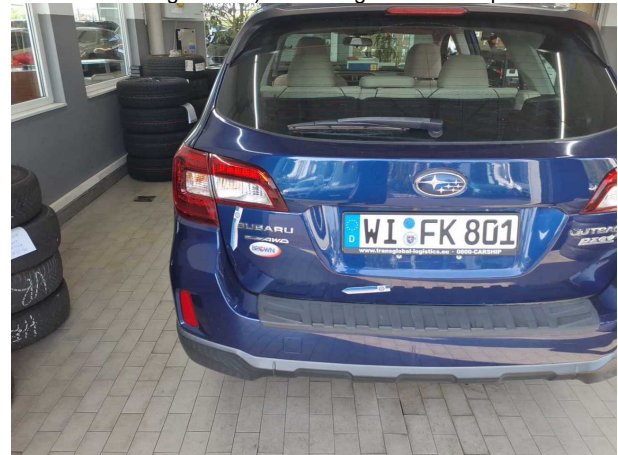
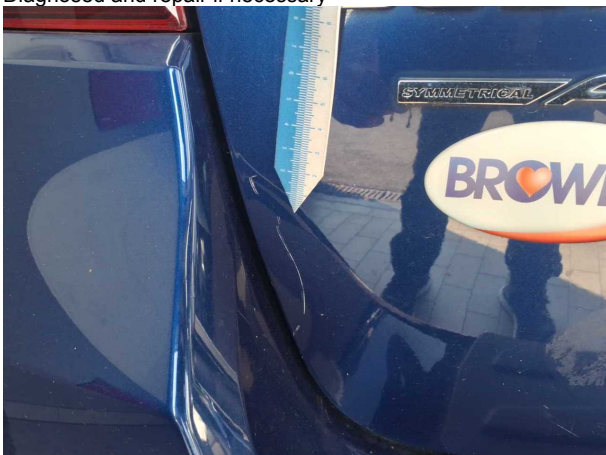
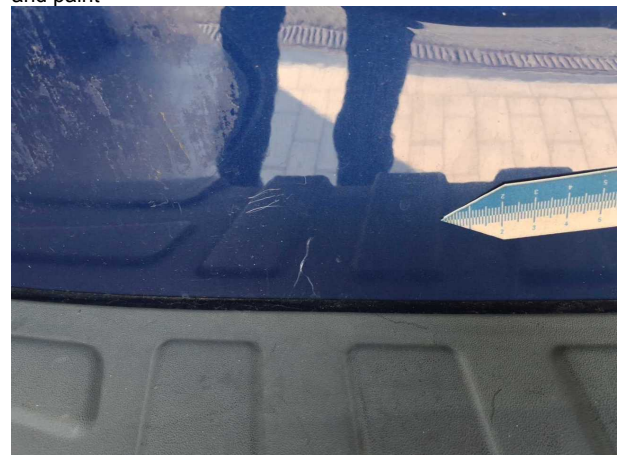
| No. | Component group | Description | Costs (Net) |
|---|---|---|---|
| 6 | Boot lid / rear door | Boot lid - Scratch(es) - Repair and paint | 450,00 € |

**Damage #6:** Boot lid / rear door: Boot lid - Scratch(es) - Repair and paint

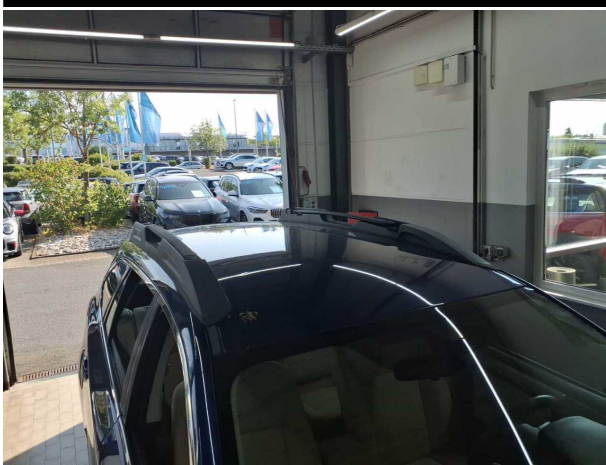
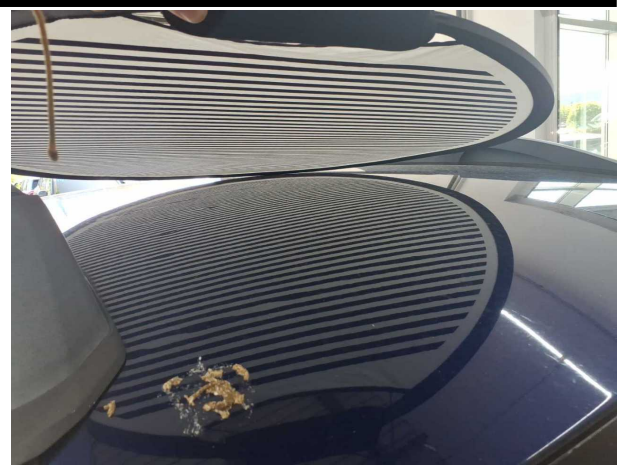
| No. | Component group | Description | Costs (Net) |
|---|---|---|---|
| 7 | Roof | Roof (Vorbehaltlich Folgekosten) - dent(s) - Smooth repair work | 500,00 € |

**Damage #7:** Roof: Roof (Vorbehaltlich Folgekosten) - dent(s) - Smooth repair work

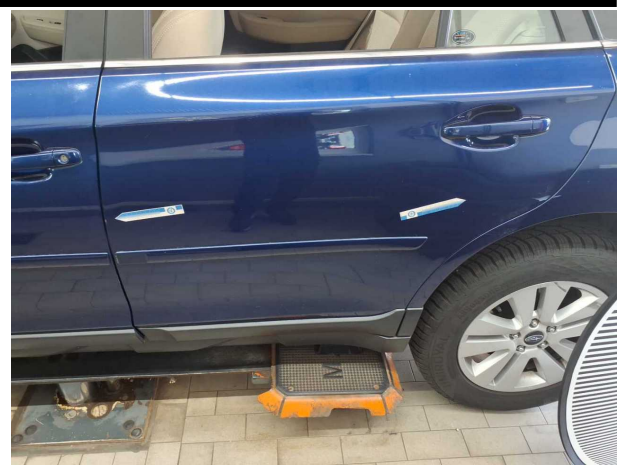
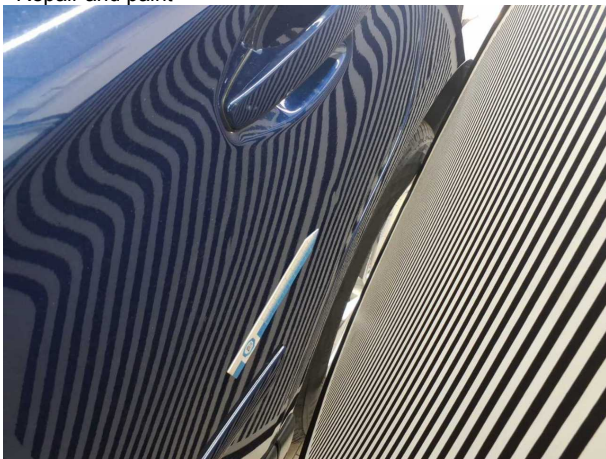
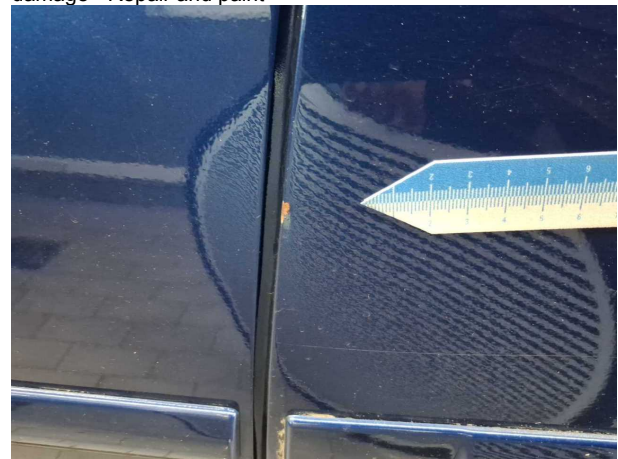
| No. | Component group | Description | Costs (Net) |
|---|---|---|---|
| 9 | Door - rear left side | Door - Dent / paintcoat damage - Repair and paint | 500,00 € |

| No. | Location | Loss in value |
|---|---|---|
| 1 | Door - rear left side, Professionally carried out, Invoice of repair done Non-existent | 100,00 € |

**Damage #9:** Door - rear left side: Door - Dent / paintcoat damage - Repair and paint

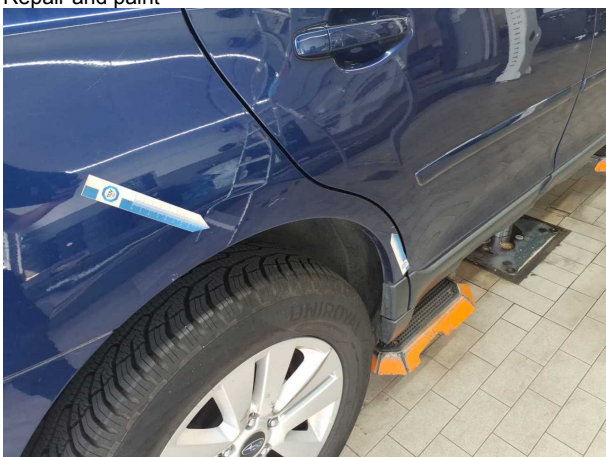
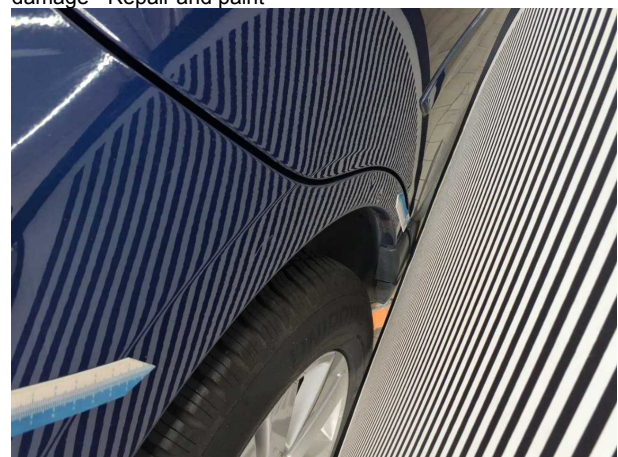
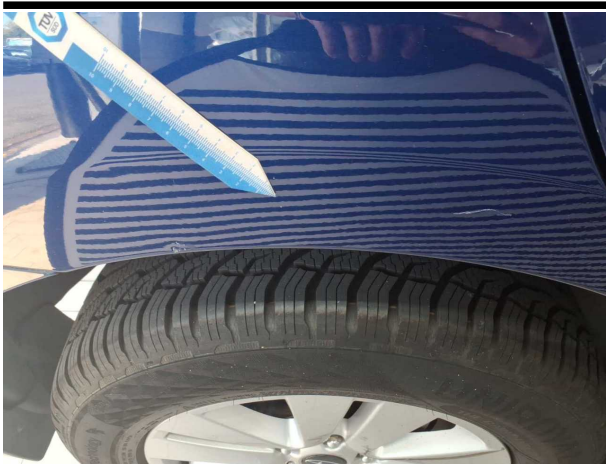
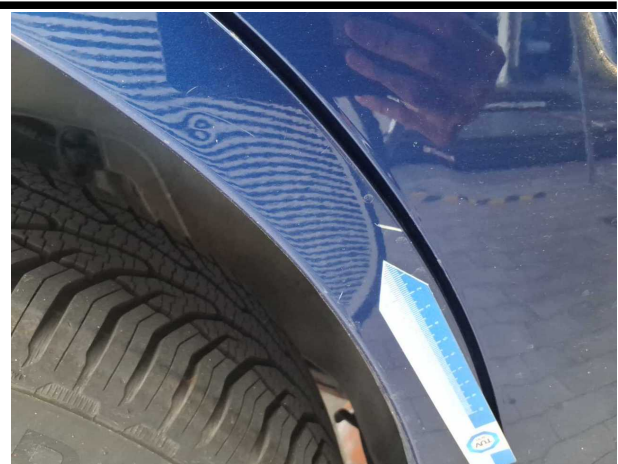
| No. | Component group | Description | Costs (Net) |
|---|---|---|---|
| 10 | Side panel - rear right side | Side panel - Dent / paintcoat damage - Repair and paint | 600,00 € |

**Damage #10:** Side panel - rear right side: Side panel - Dent / paintcoat damage - Repair and paint

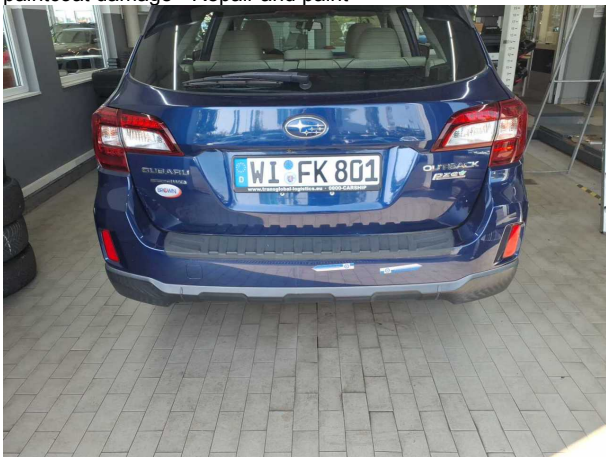
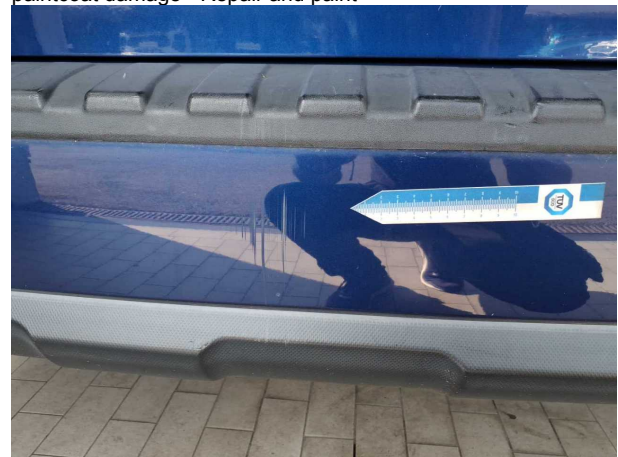
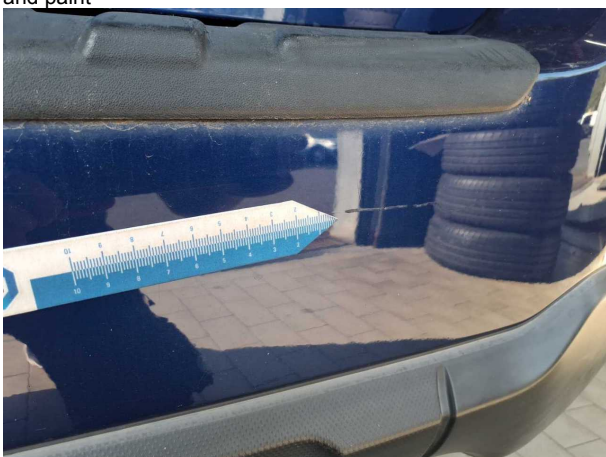
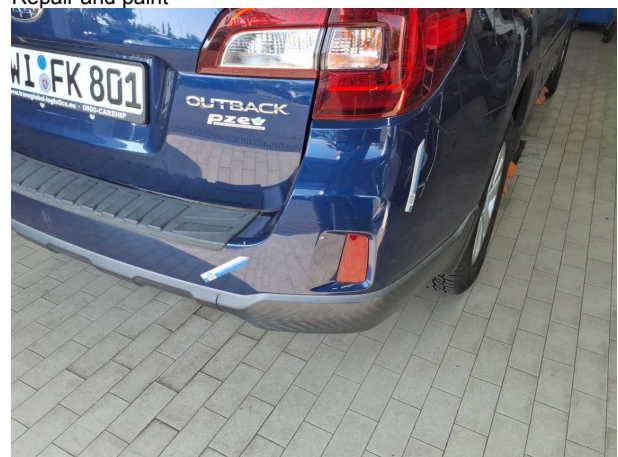
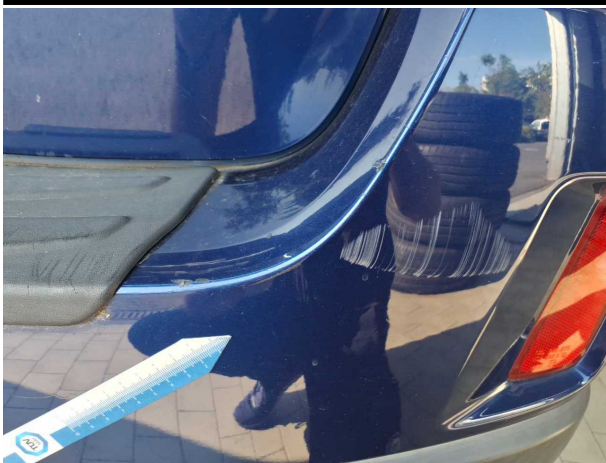
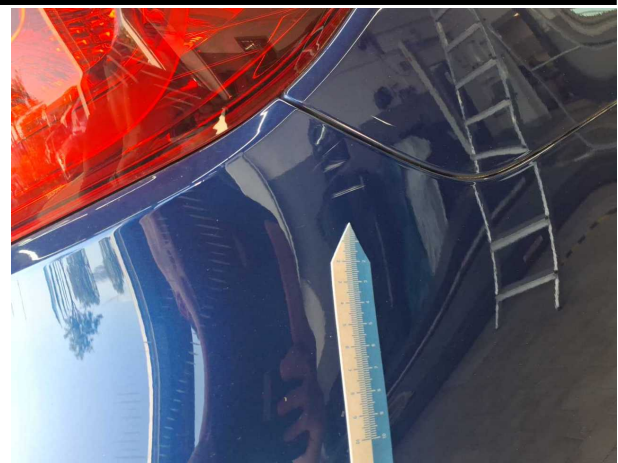
| No. | Component group | Description | Costs (Net) |
|---|---|---|---|
| 11 | Rear bumper | Rear bumper - Scratch(es) - Repair and paint | 650,00 € |

**Damage #11:** Rear bumper: Rear bumper - Scratch(es) - Repair and paint

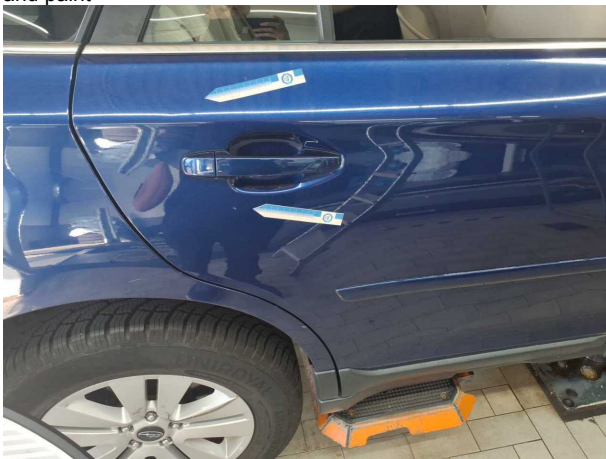
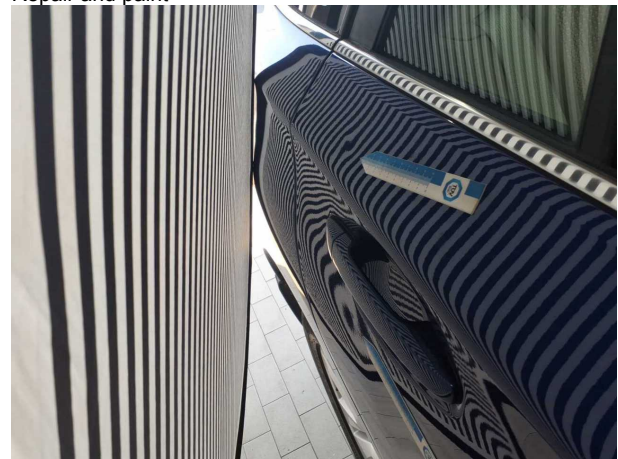
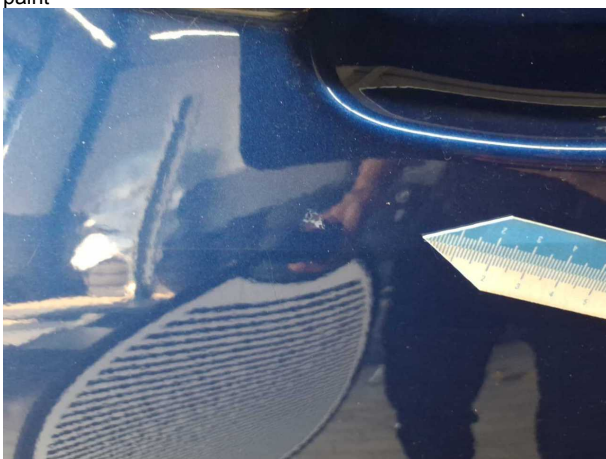
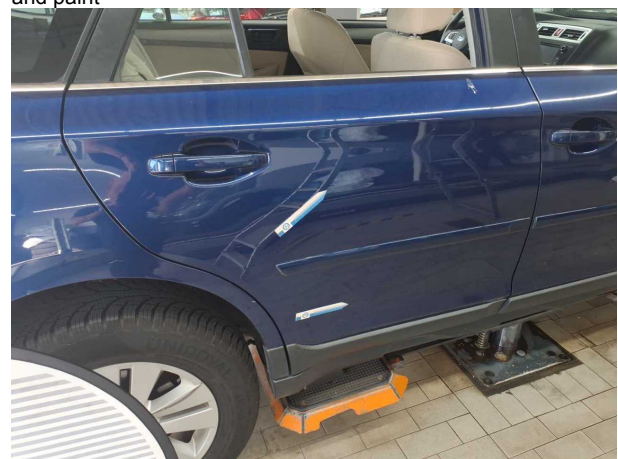
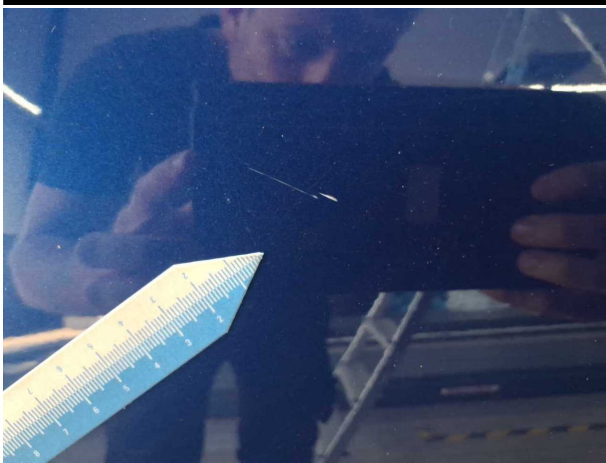
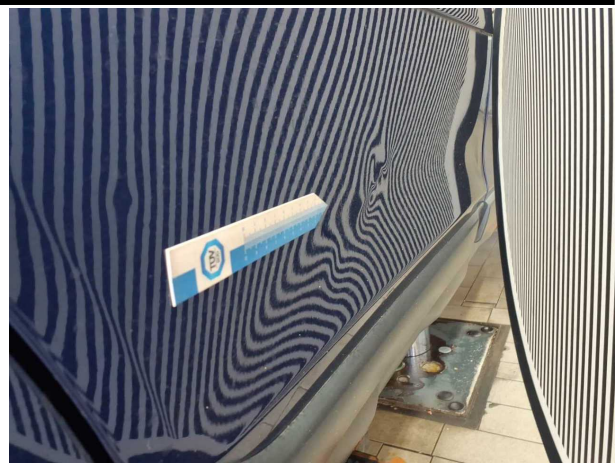
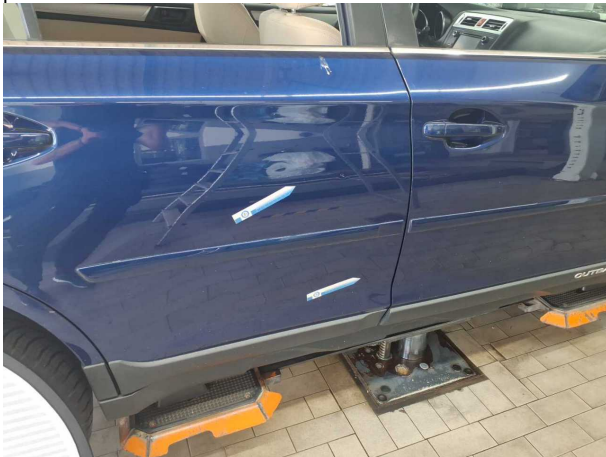
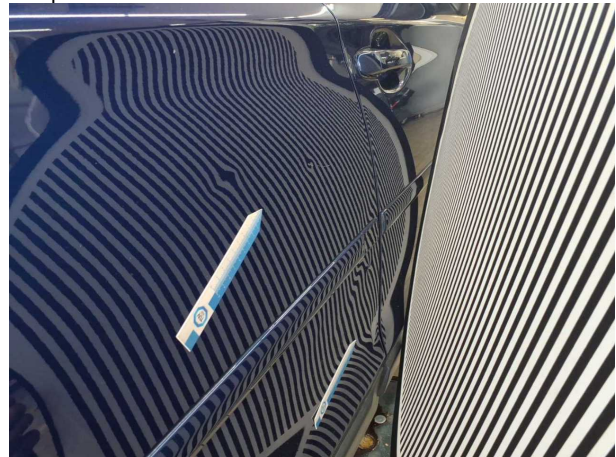
| No. | Component group | Description | Costs (Net) |
|---|---|---|---|
| 12 | Door - rear right side | Door - Damaged - Repair and paint | 1.000,00 € |

**Damage #12:** Door - rear right side: Door - Damaged - Repair and paint
